Structural Health Monitoring Of Pavements

**Ben Franklin Center
for SHM**

Ghassan Chehab

**Assistant Professor
Dept. of Civil Engineering
Penn State University**

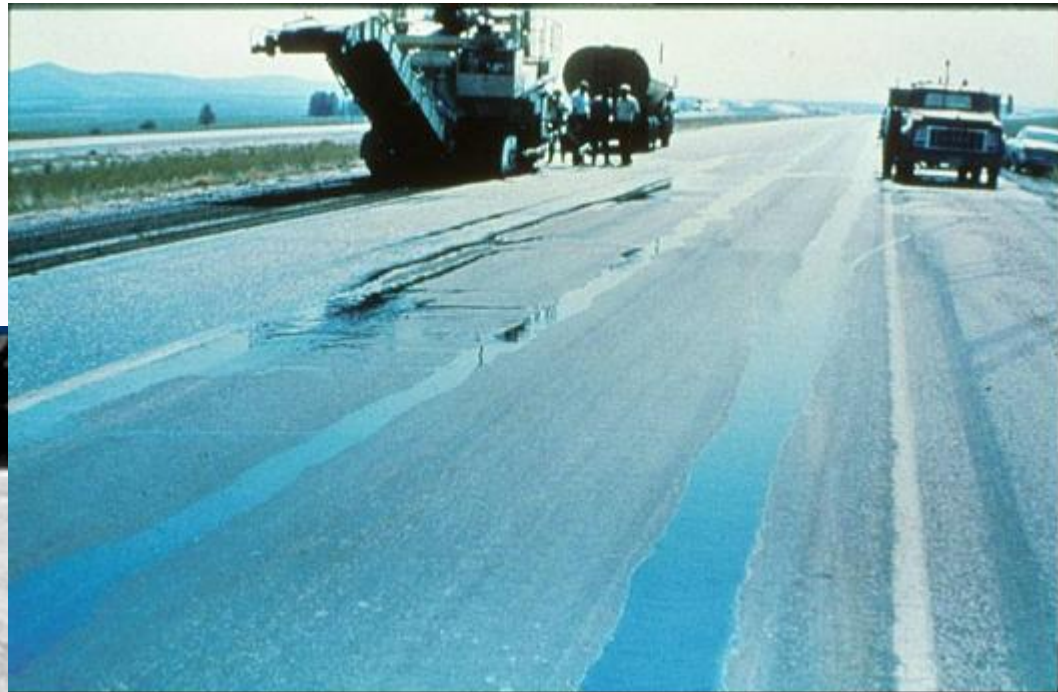
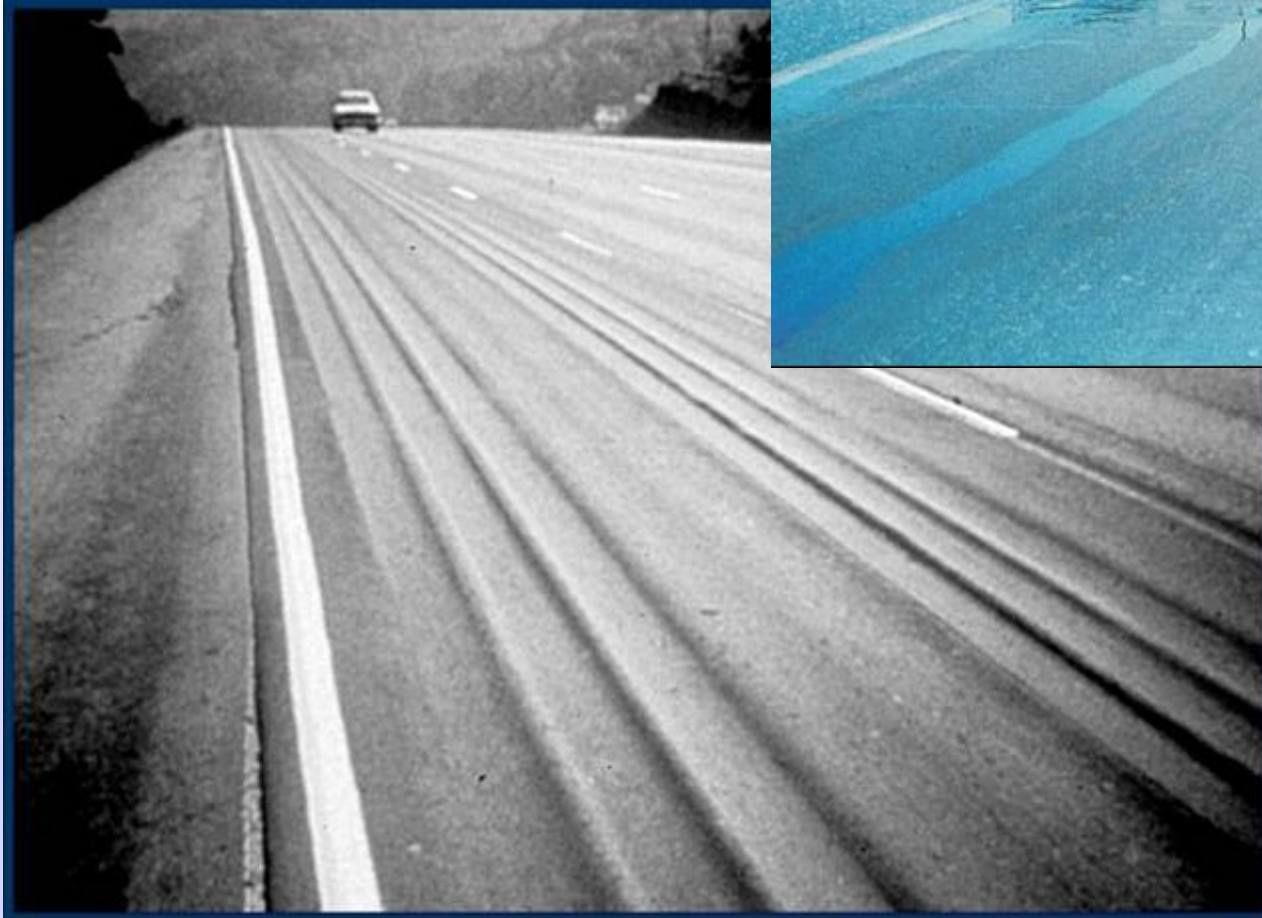
Rutting

AC layer deformation at high temperatures

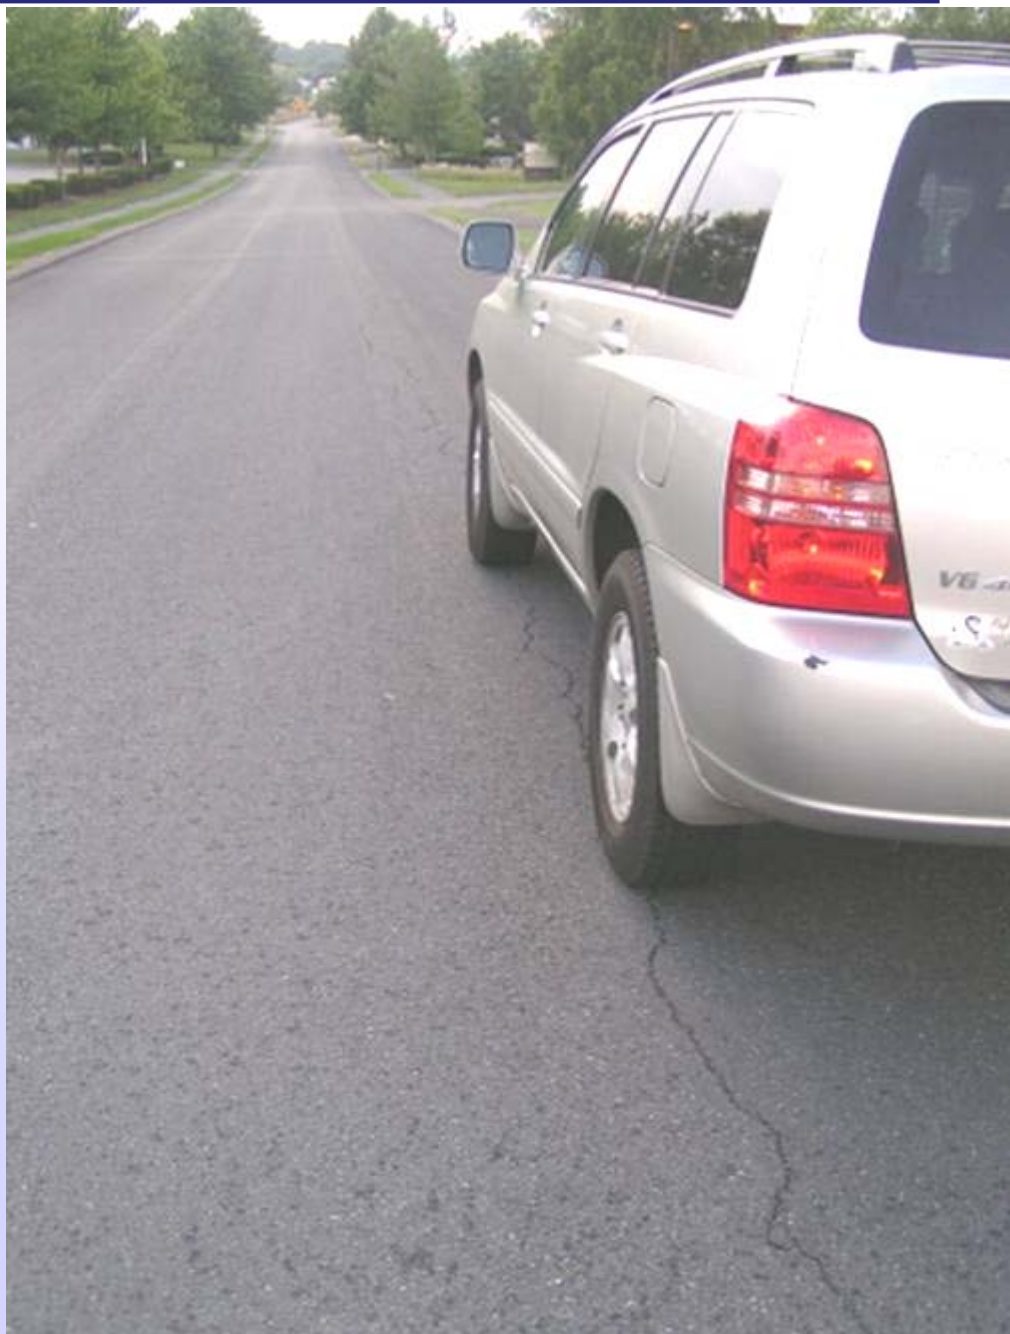
Fatigue Cracking

Cracks in AC layer at low/medium temperatures due to repetitive loading

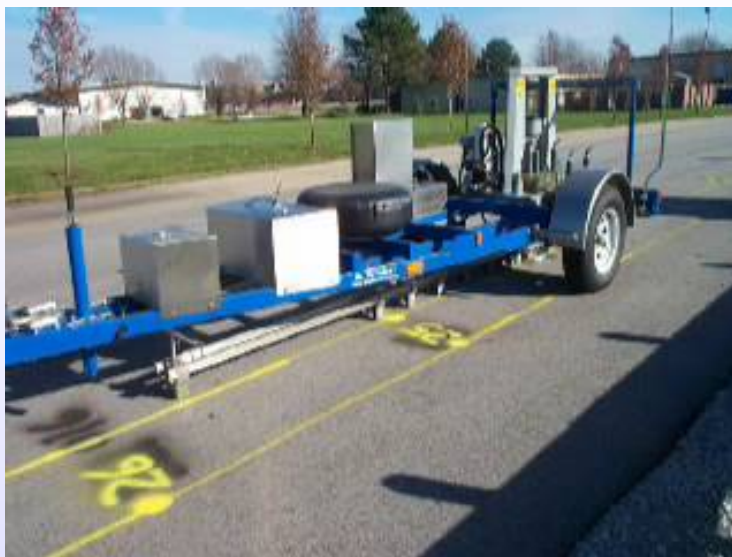
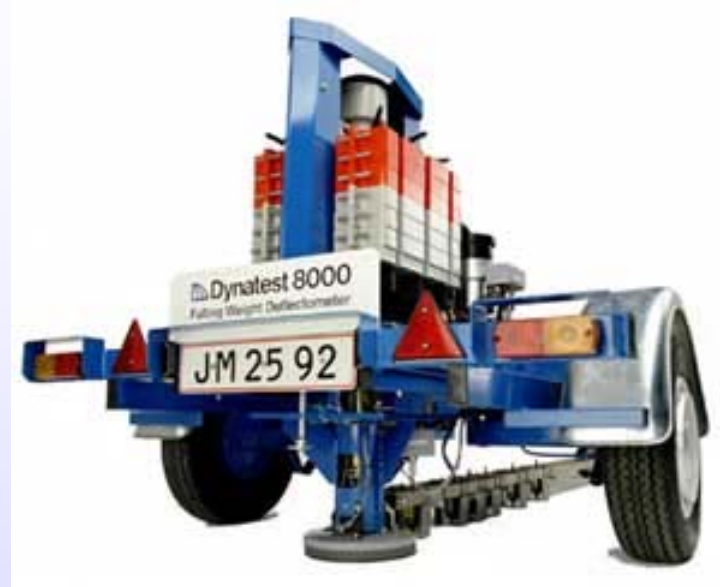
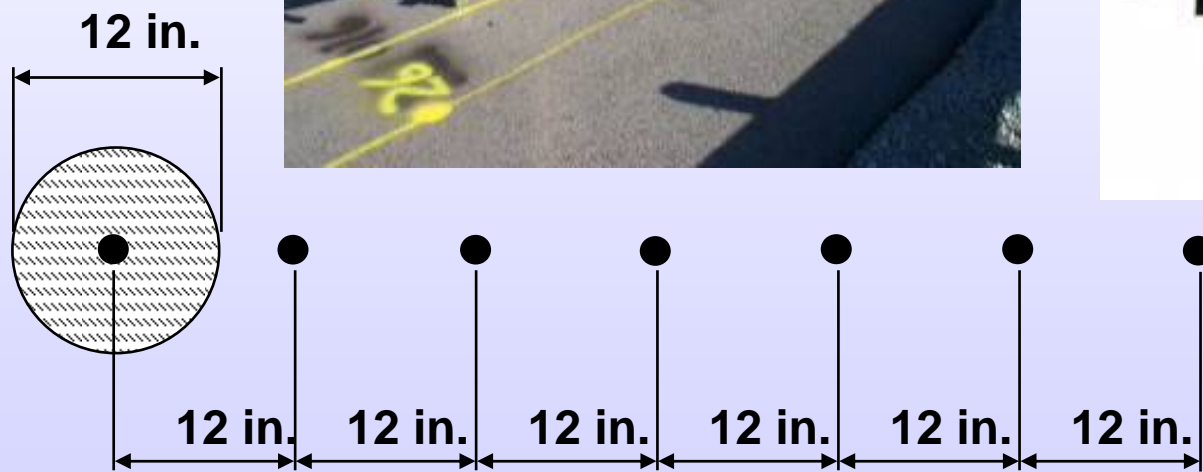
Falling Wheel Deflectometer

Loading Wheel Contact Area

Sensor

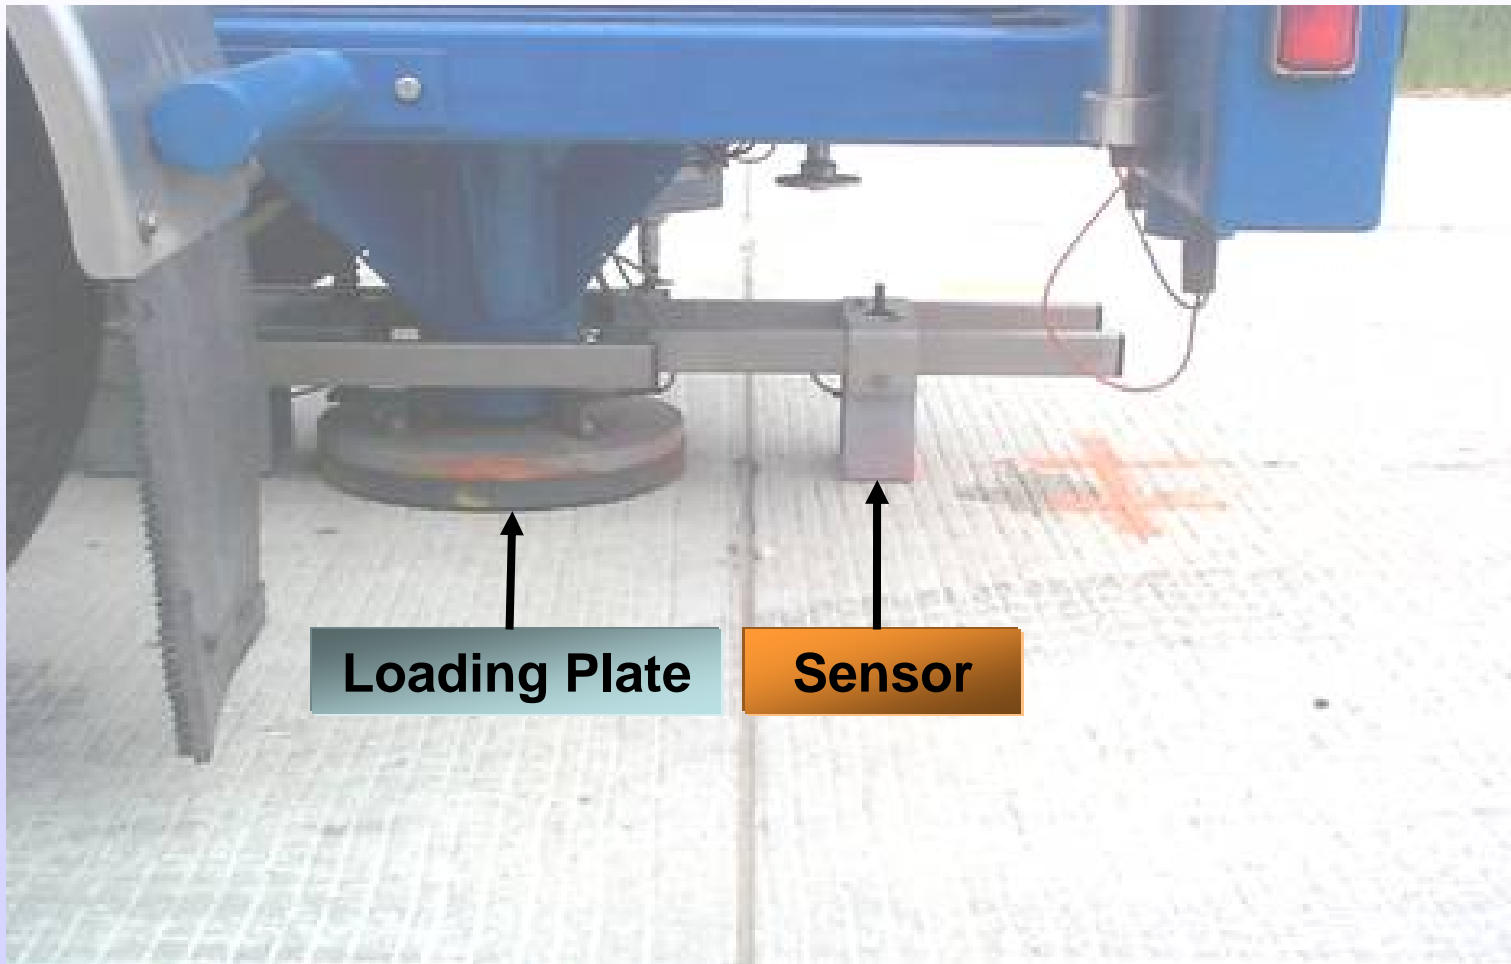
FWD for Structural Evaluation

Loading Plate

Sensor

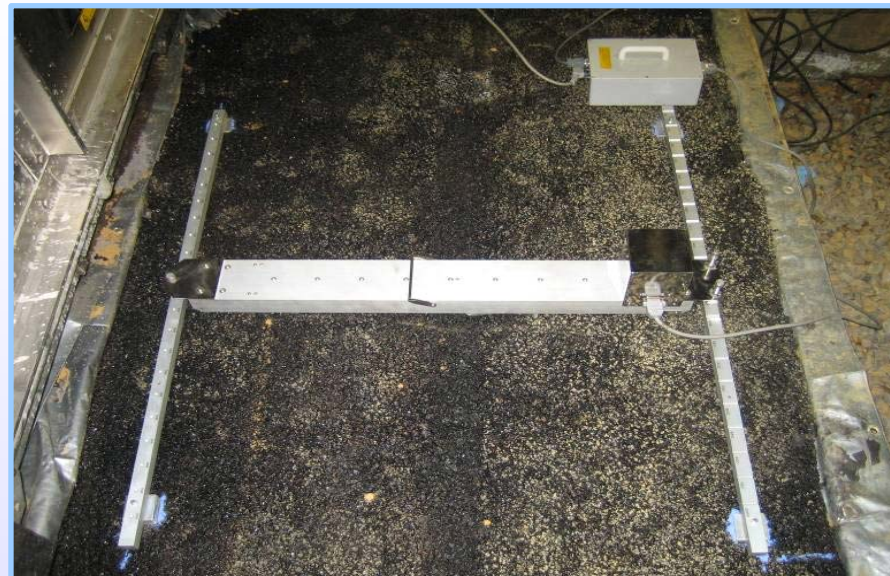
Vehicle-mounted Profilometer

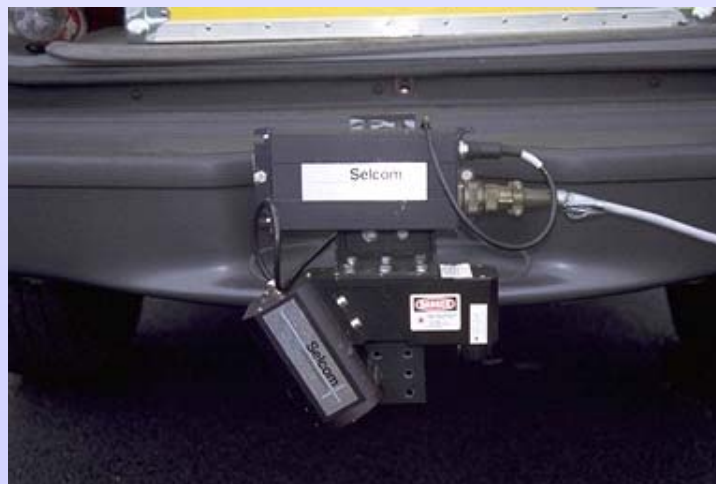
Pavement-mounted Profilometer
