Center of Excellence in Structural Health Monitoring
Inaugural meeting - April 12, 2007

Structural Health Monitoring of Civil Infrastructure

Evaluation of FRP Composite Repairs for Concrete Structures

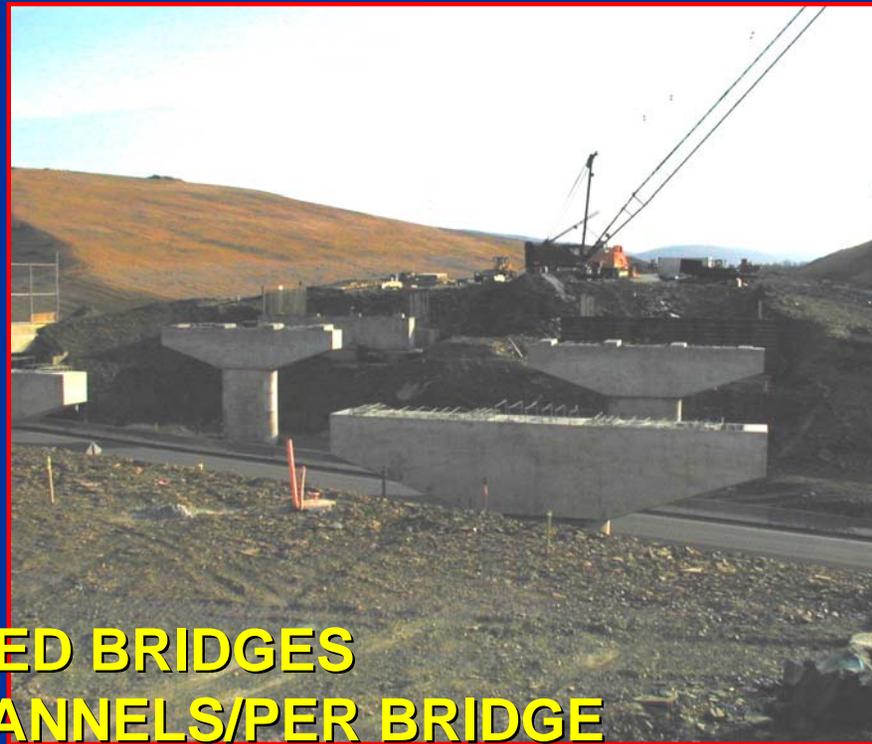
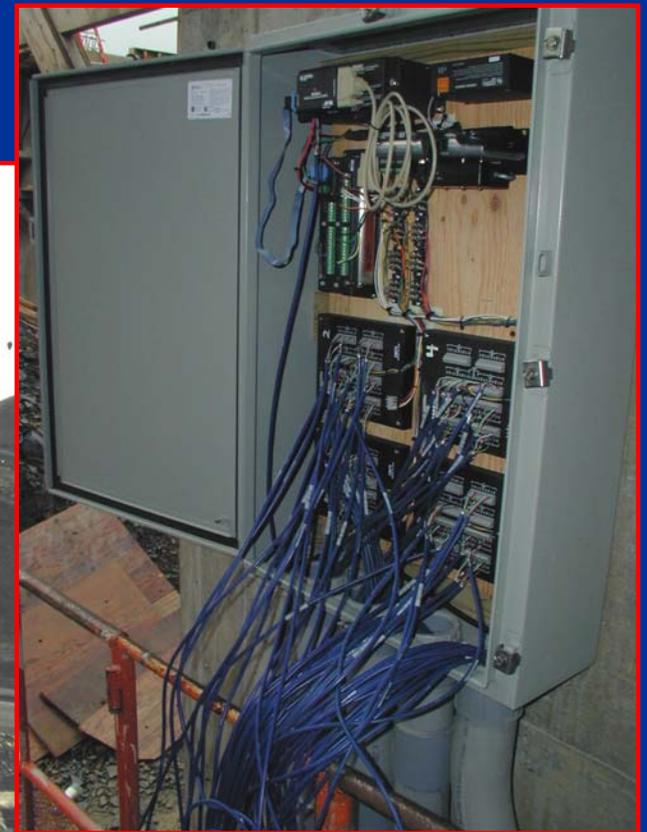
Long Term Monitoring of 4 Integral Abutment Bridges – *J. Laman*

- **4 MONITORED BRIDGES**
- **64 to 80 CHANNELS/PER BRIDGE**
- **REMOTE DATA COLLECTION**

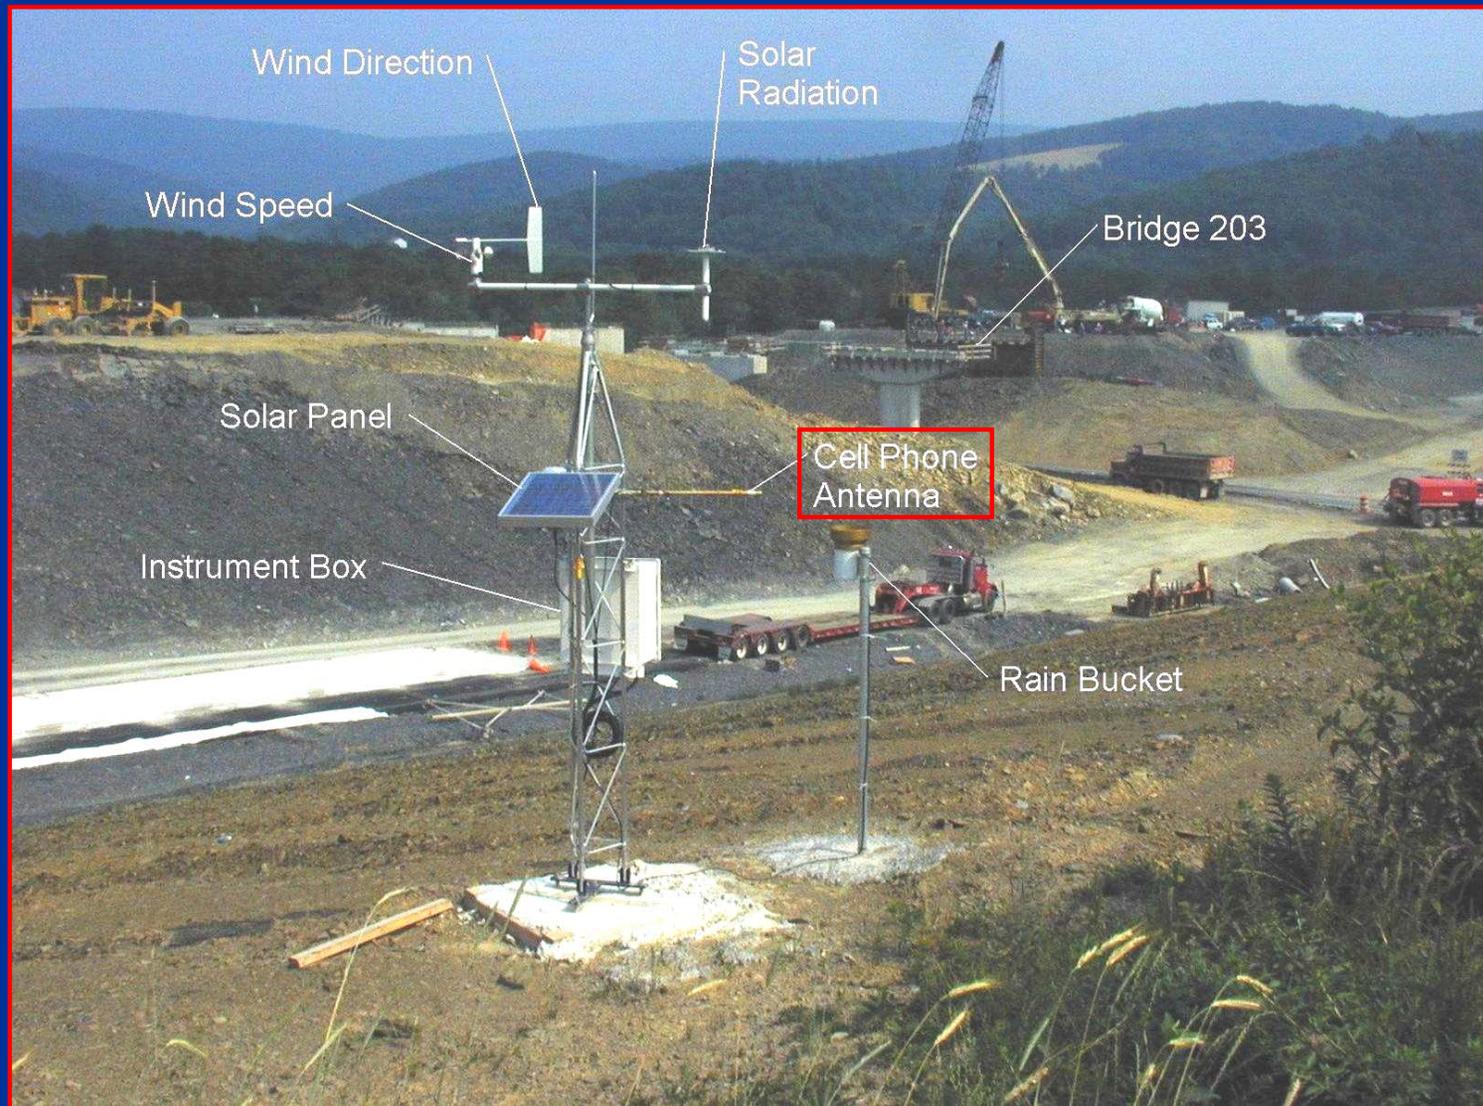
Continuous, Remote Environmental Load Monitoring

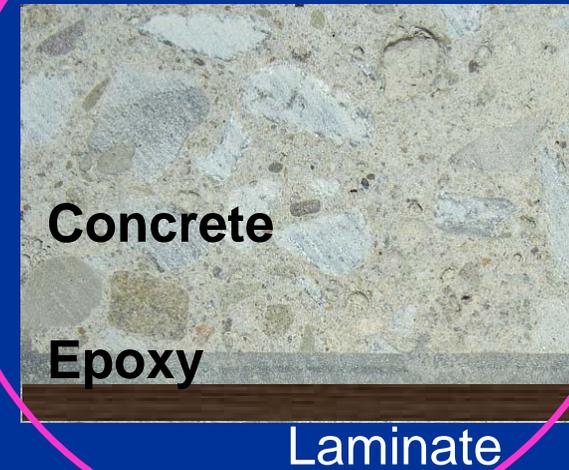
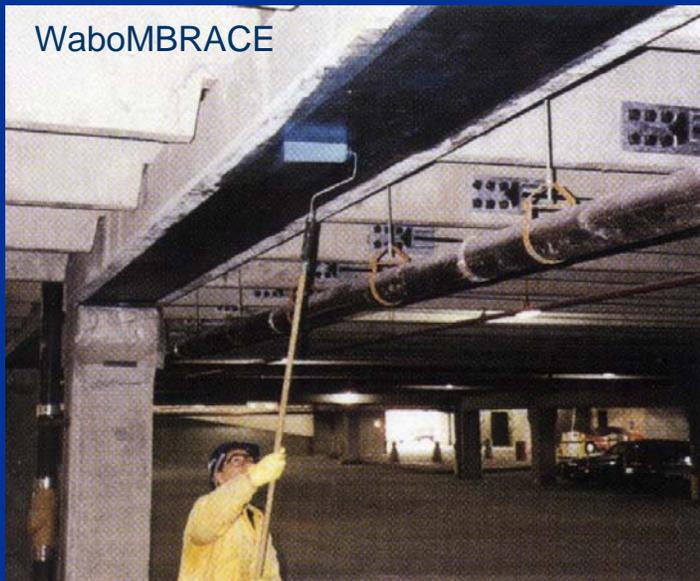
Concrete-Epoxy Interface (CEI)

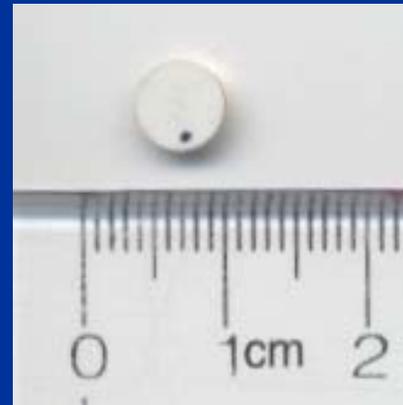
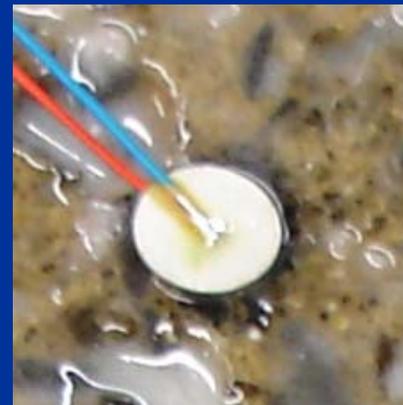
Ultrasonic Guided Wave Sensor

- PZT disk sensor
 - Diameter - 0.25 in (6.35 mm)
 - Thickness – 0.01 in (2.54 mm)
 - Radial vibration at 350 kHz
 - Placed in the epoxy bonding layer

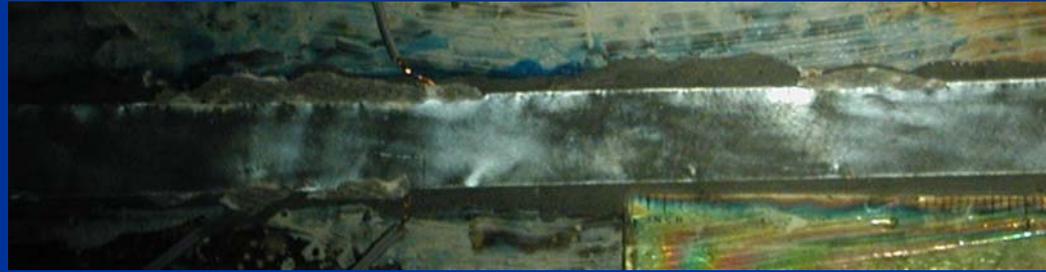
239 psi

PE Fringes During Test
