Health Monitoring of Rotating Equipment from Torsional Vibration Features

Martin W. Trethewey

Department of Mechanical and Nuclear Engineering
Penn State University

April 13, 2007

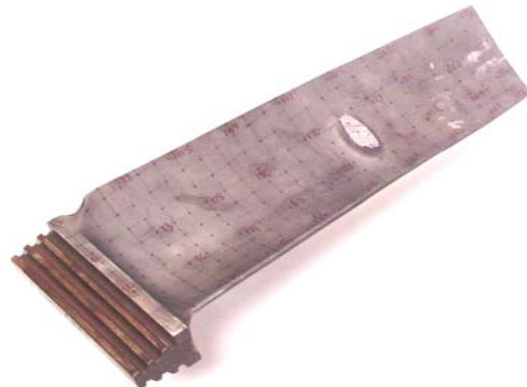
Fossil Boiler Feed Pump Blades

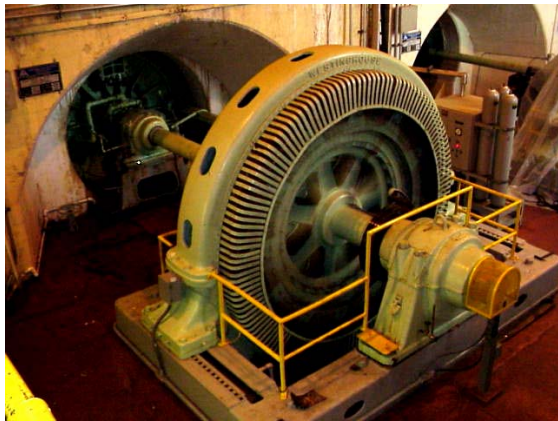
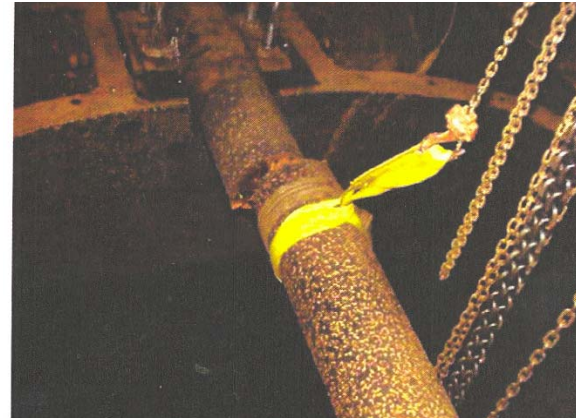
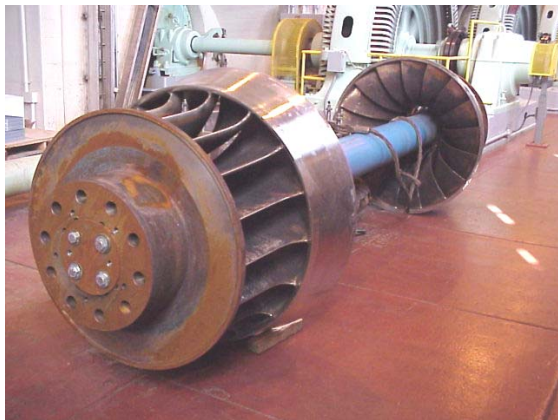
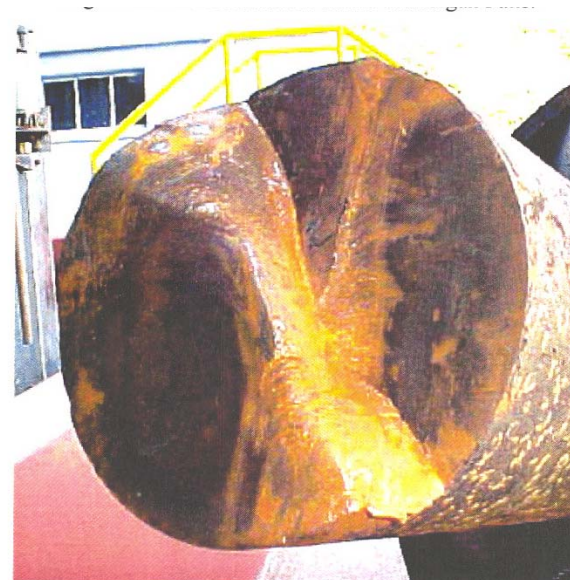
Hydro Turbine Driveshaft

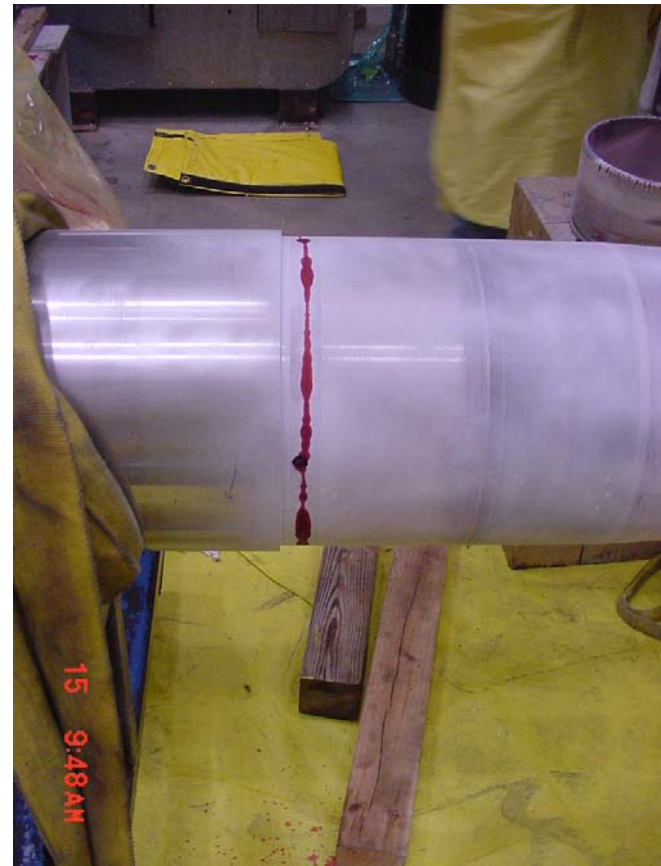
June 2002

TVA Sequoyah RCP 2-1

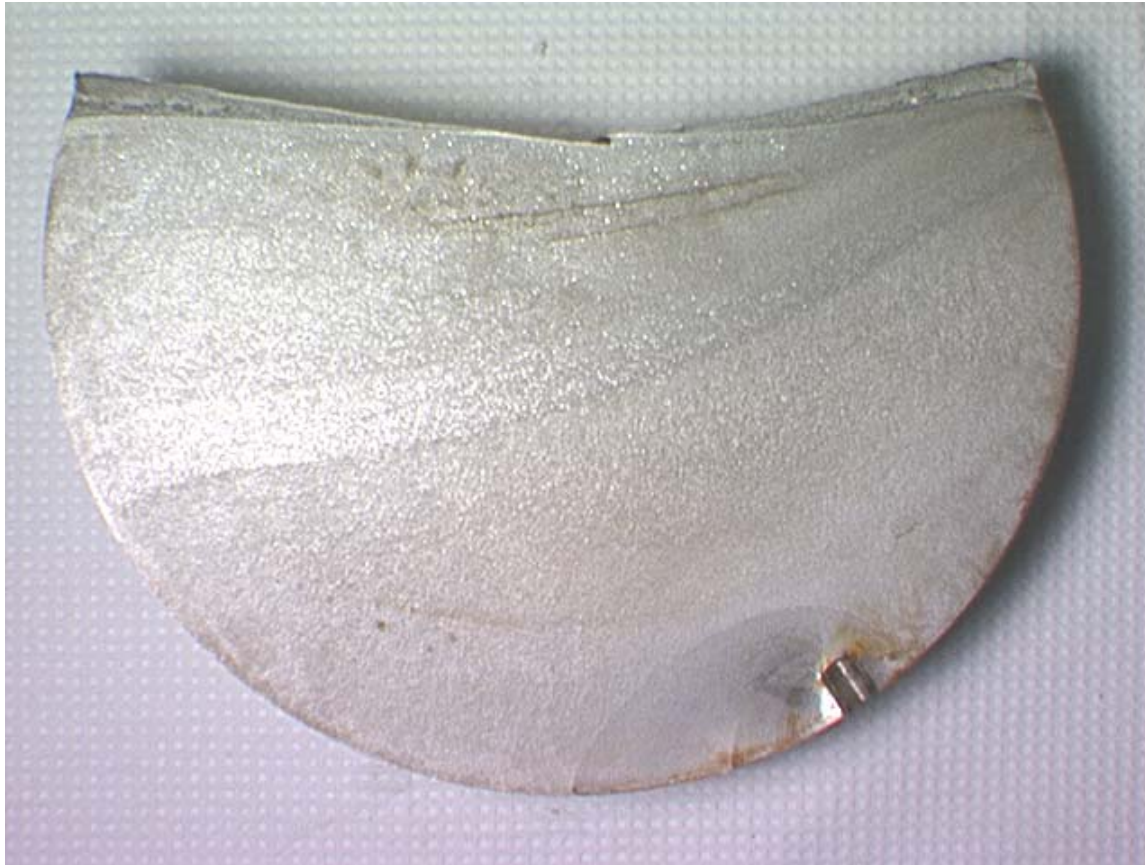
TVA Sequoyah RCP 1-4 2000

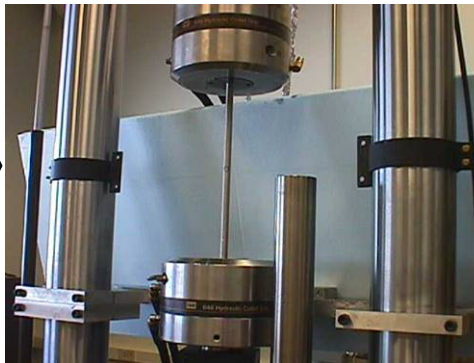
Torsional Stiffness

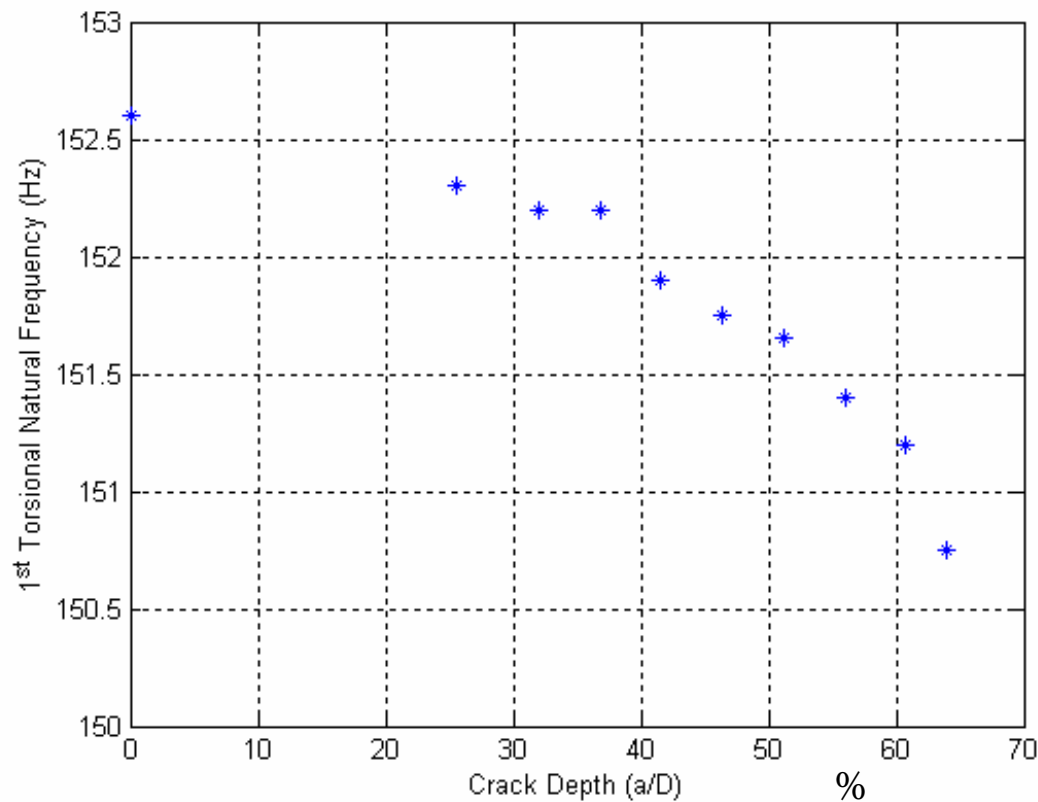
Torsional Natural Frequency versus Fatigue Crack Depth

- As a crack propagates
 - Stiffness decreases
 - Decrease in torsional natural frequency
- Torsional domain less susceptible to
 - Seal rubs
 - Changes in film bearing stiffness
 - Thermal growth
 - Misalignment
- If a torsional natural frequency change is observed
 - A change in the line shaft dynamics occurred

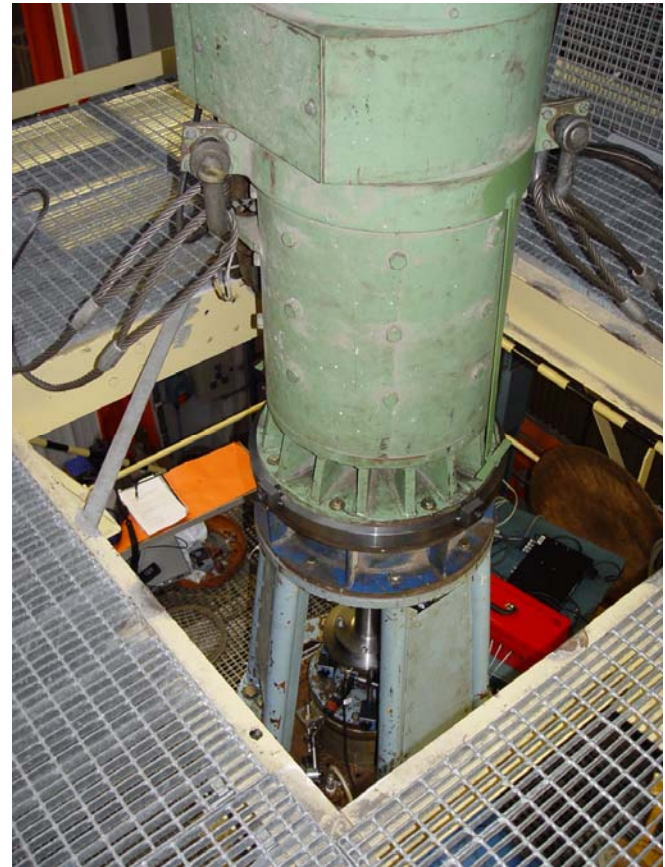
41% Reduced Scale RCP Loop

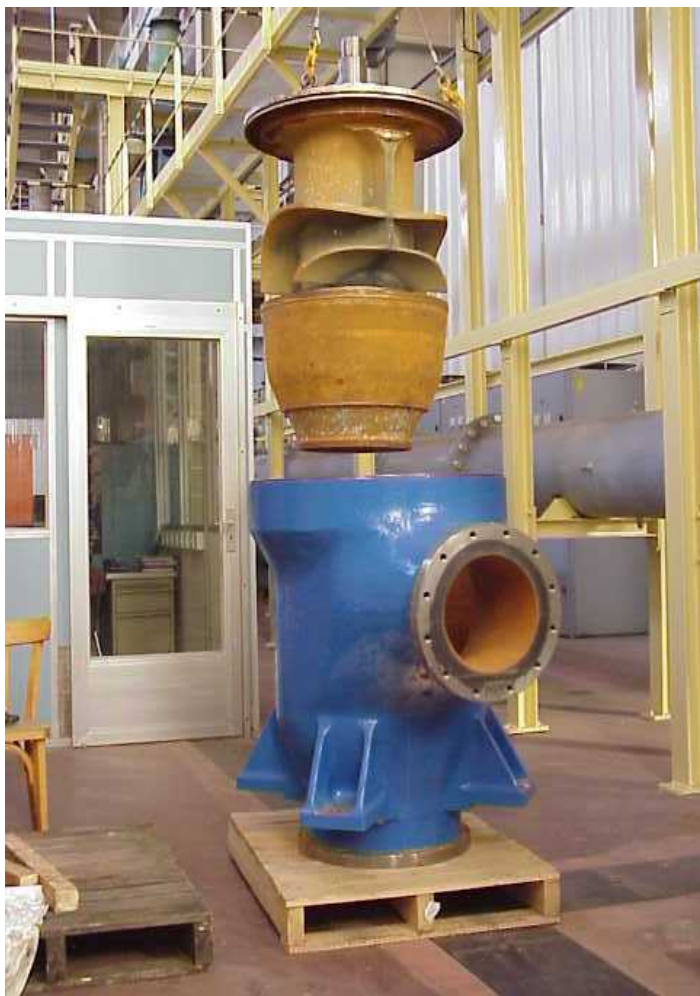
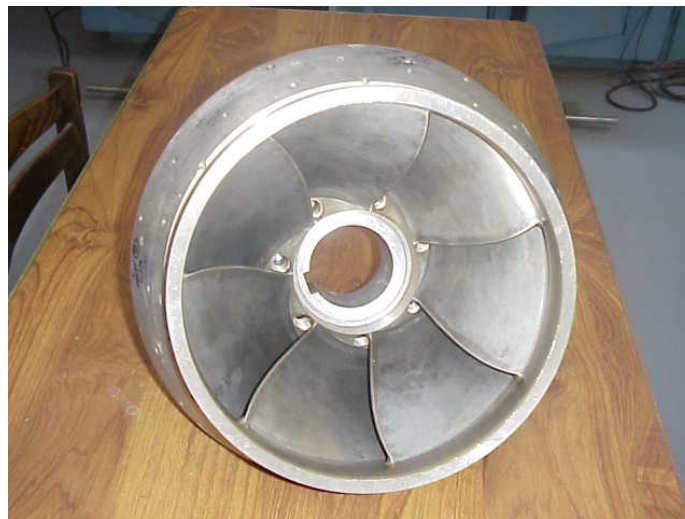
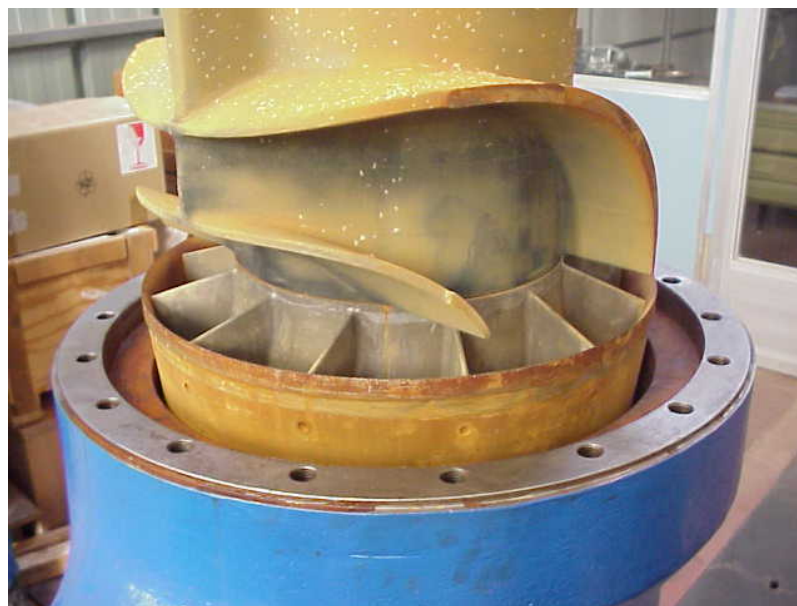
Reduced Scale 93A RCP

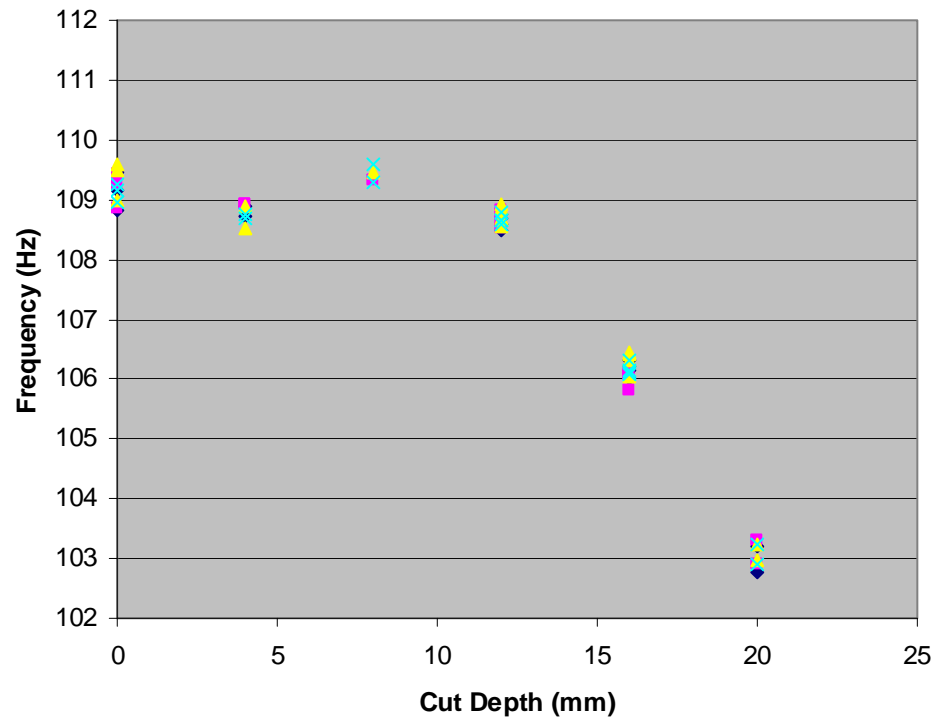
Circumferential Cuts

1st Torsional Frequency

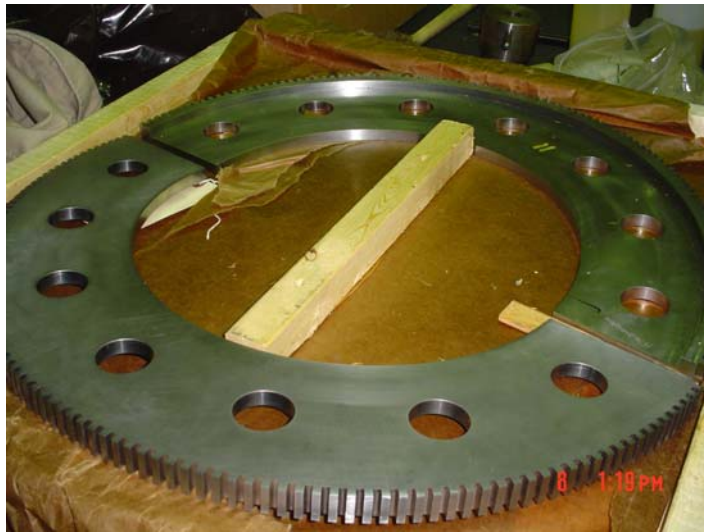
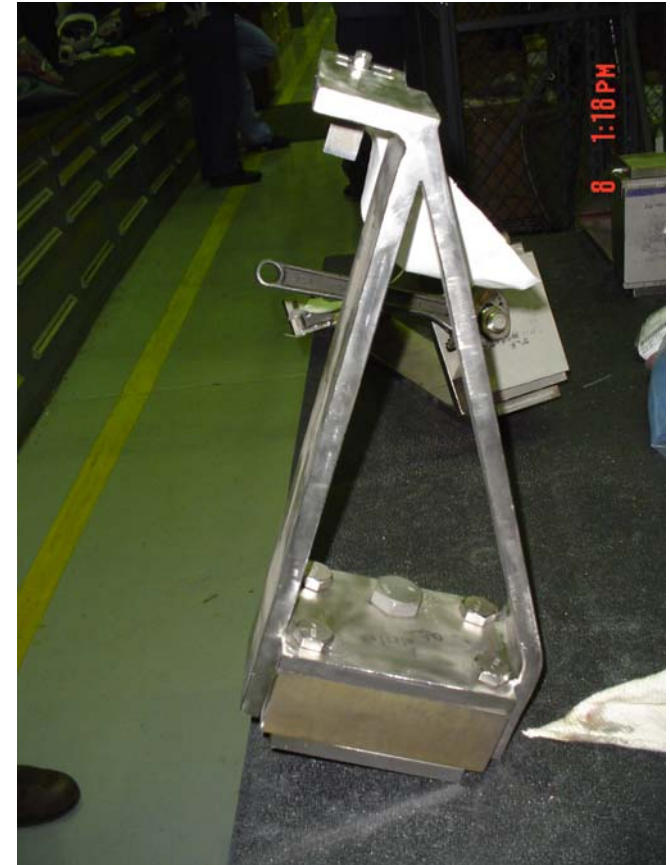
93A RCP Torsional Hardware

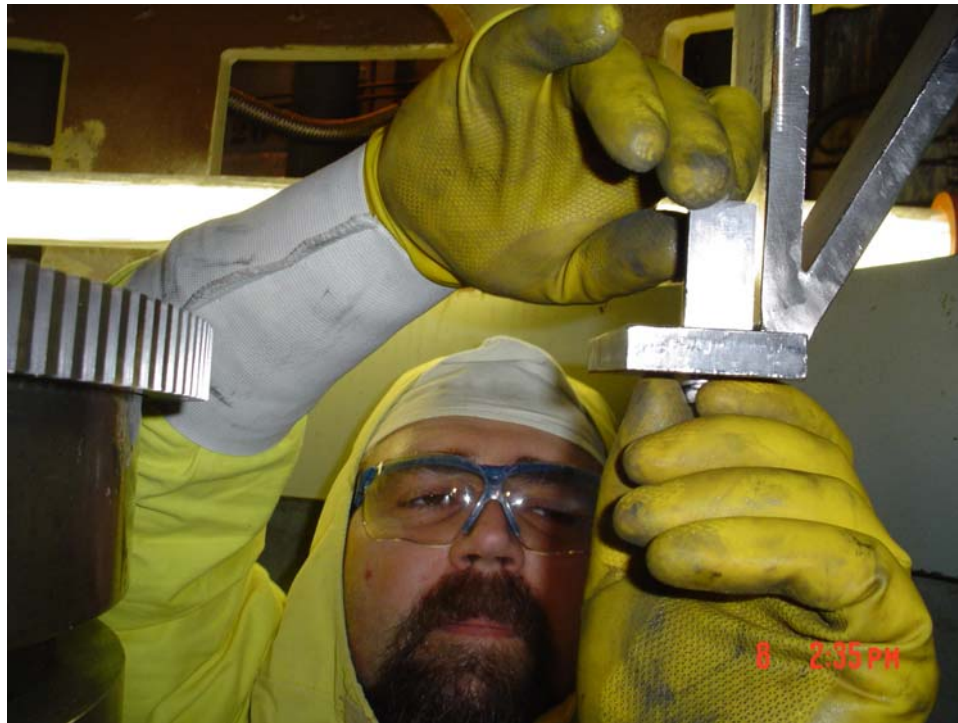
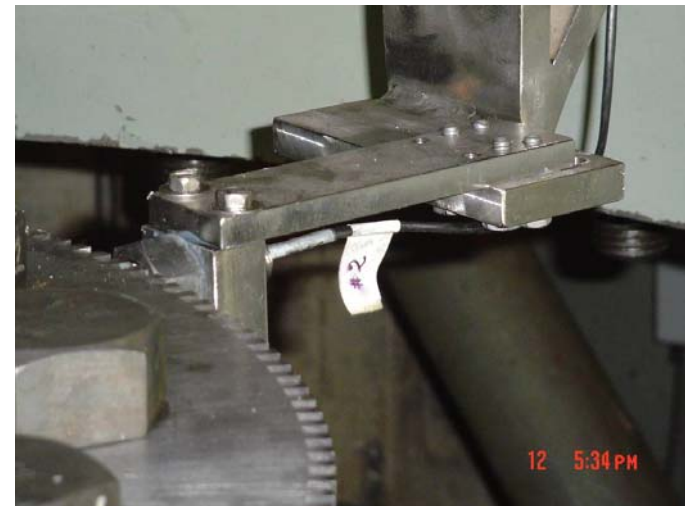
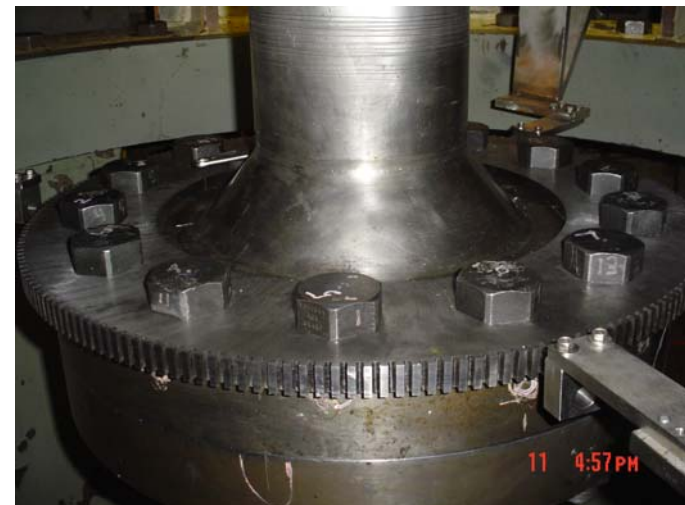
Mechanical Installation
